Infortrend[®]

New Release and Update Information

Firmware Core: 3.34A06

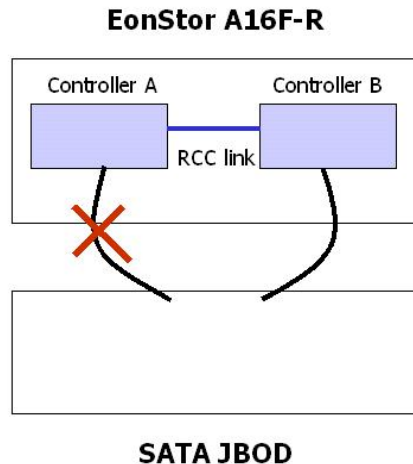
Drive-side rerouting support is a special implementation for the combination of the ES A16F-R SATA RAID and SATA JBOD. Featuring two (2) FC host channels and one (1) RCC route between partner controllers, the A16F-R has only one (1) FC loop left for drive connection. Each RAID controller has an FC link to the drive enclosure. In the diagram shown below, rerouting is required in case any drive-side link becomes broken.

Note that the two (2) FC links from the partner controllers are looped together into a single drive-loop. Once I/O timeout is detected, I/O traffic is rerouted through the surviving link to the JBOD. Performance drag will be experienced and the controllers will continuously poll the drive loop for a restored link.
